HISTORY OF ATLAS ABLE-5A
FLORIDA OPERATIONS

October 1960

SPACE TECHNOLOGY LABORATORIES, INC.
P. O. Box 95001
Los Angeles 45, California

Atlas Able-5A Vehicle

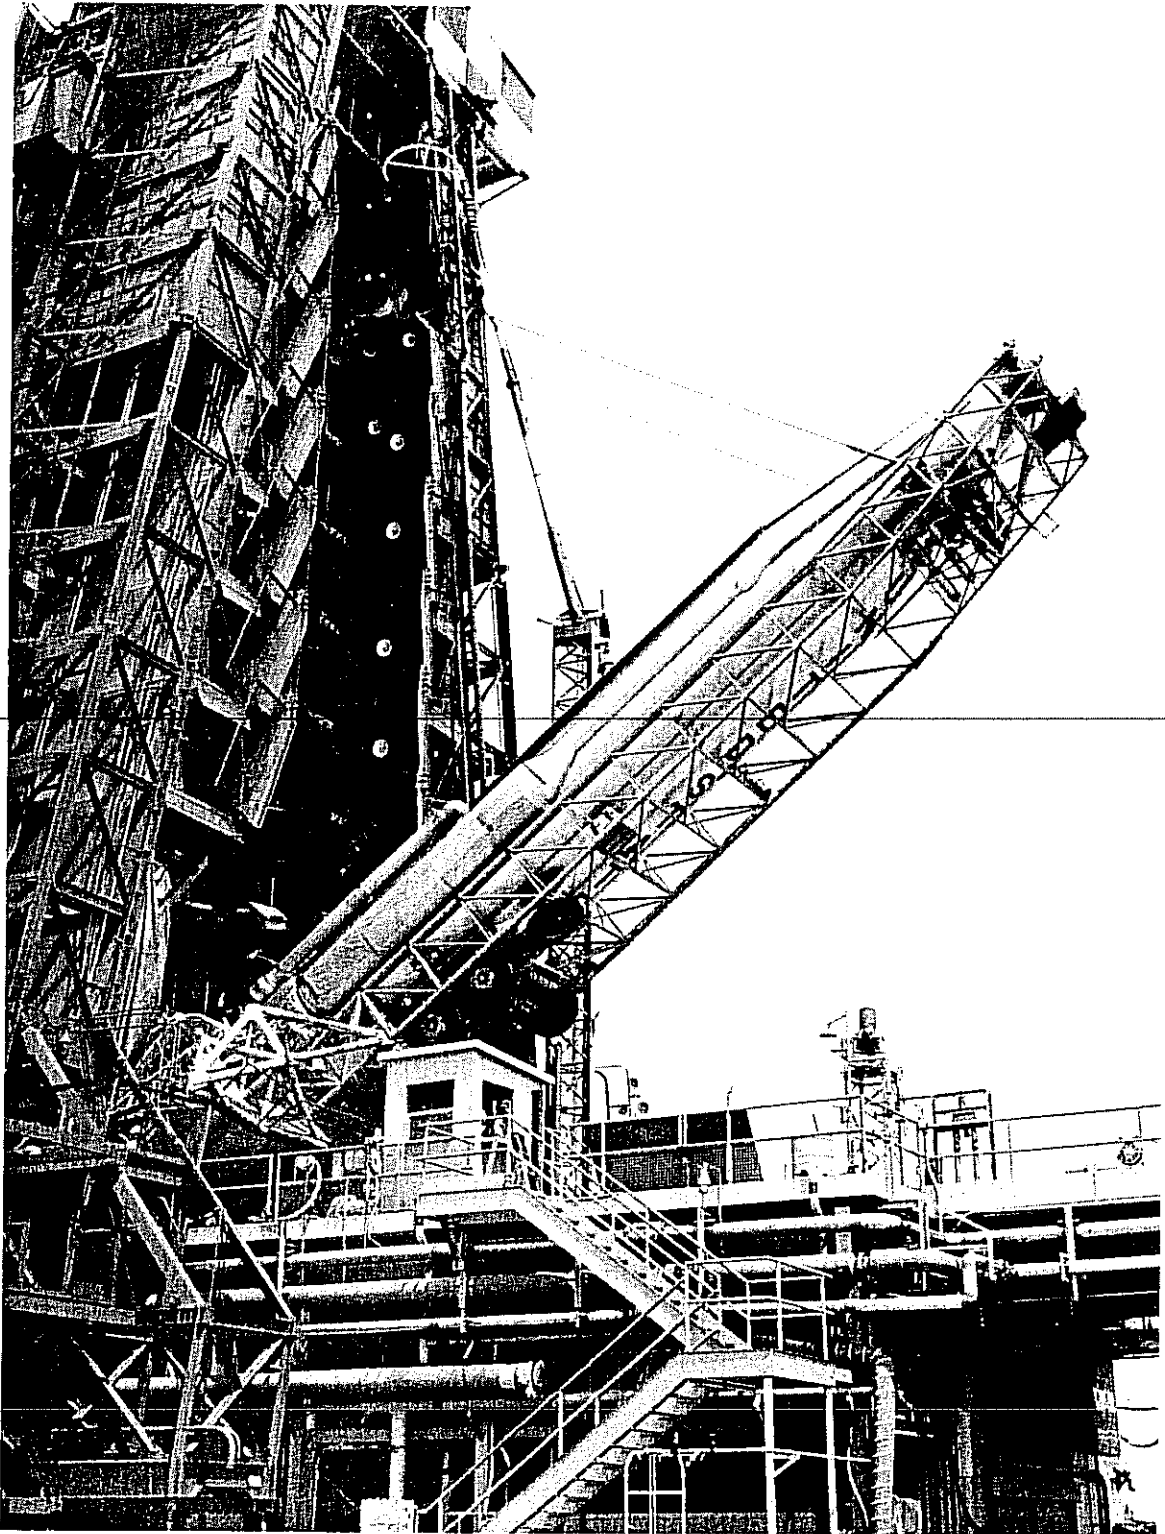
Figure 1. Installation of Atlas 80D on Pad 12. Note how Launcher Mechanism Tilts to Mate with Atlas Handling Trailer.

Convair installed Atlas 80D on the launch pad of Complex 12 during the early afternoon. (See Figure 1.)
